# **Lowland Raised Bog restoration**

Restoration of degraded peat surfaces and cut peat faces. Glasson Moss SSSI. 2007

Glasson Moss SSSI - part of South Solway Mosses North Cumbria

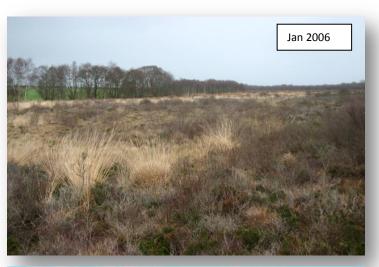
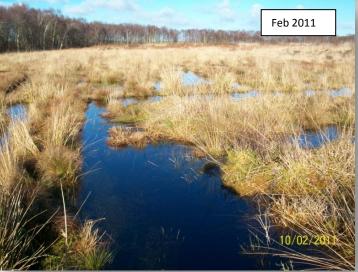
- Peat extraction peat surface left at a variety of different levels and the active M18 vegetation replaced by Purple moor grass (*Molinia caerulea*) and/or Heather (*Calluna vulgaris*) and Silver Birch (*Betula pendula*). This vegetation was exacerbating the degradation of the top 50- 75cm of the remaining 1-2m of peat through rainfall interception, transpiration and the development of flow paths associated with root systems.
- Peat face. 2m high cut face. Exposure to air leads to drying and degrading of the

ombrotrophic peat. This effect extends to up to 40m onto the active M18 surface causing a change to Heather dominated communities.

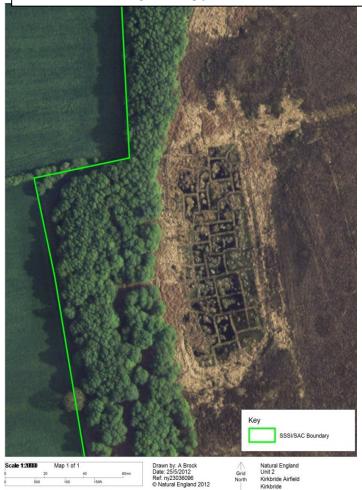
#### 2010 Aerial showing bunding pattern

- Construct water tight cells of 400m<sup>2</sup> by building bunds 500mm above ground level which are capped with turf.
- Each cell is higher than the previous until they butt into the bund built at the bottom of the cut face. This gives a 'Paddy field' effect (when viewed from above)

The purpose of the bunds is to slow the movement of below and above ground water off the bog and retain as much of it as possible on the bog. Each bund acts as a water control mechanism – there are no pipes to block or bend, instead the water is held in the cell by the creation of an almost impermeable bund of 'clay like' ombrotrophic peat. The water level is dictated by the height of the 'clay like' peat mound. The turf acts as permeable membrane but protects the bund from drying out and eroding.
